Thybotech aps  
Fjernvarme pumpe  
PO:  
Project:  
26. oktober 2016

Sdr. Herred Kraftvarme  
102222

*Kvalitetssikringsdokumentation*

Work order and QC report

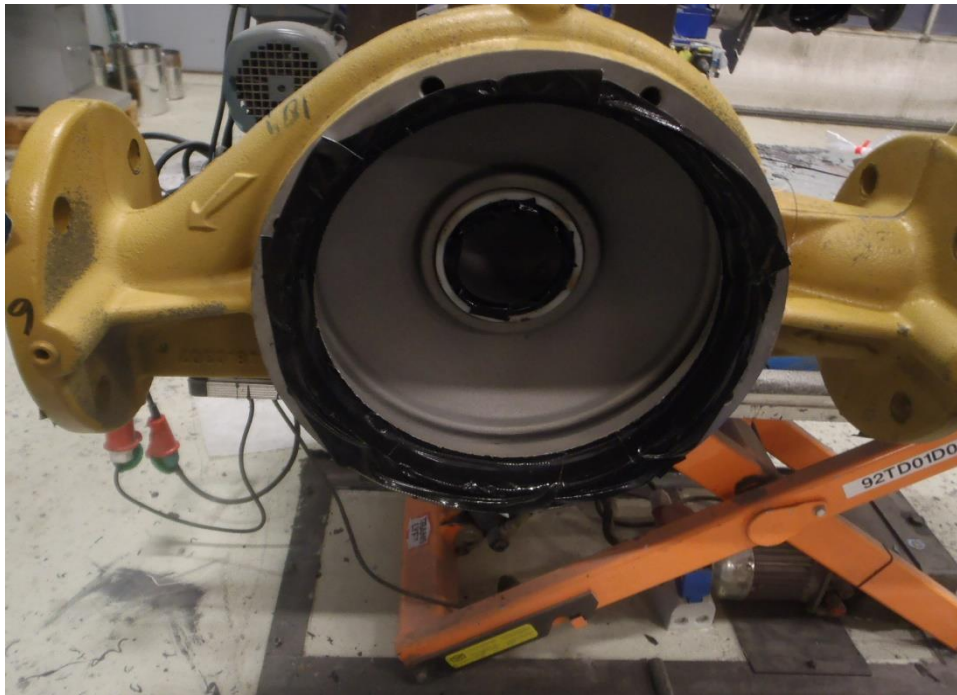
Blæst pumpe

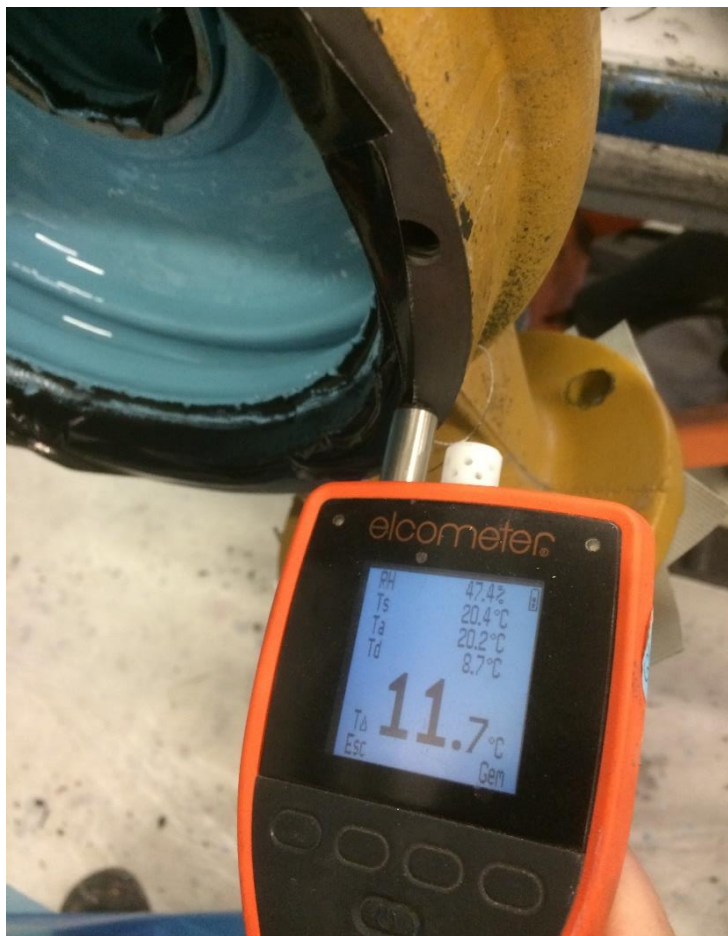
Første coat

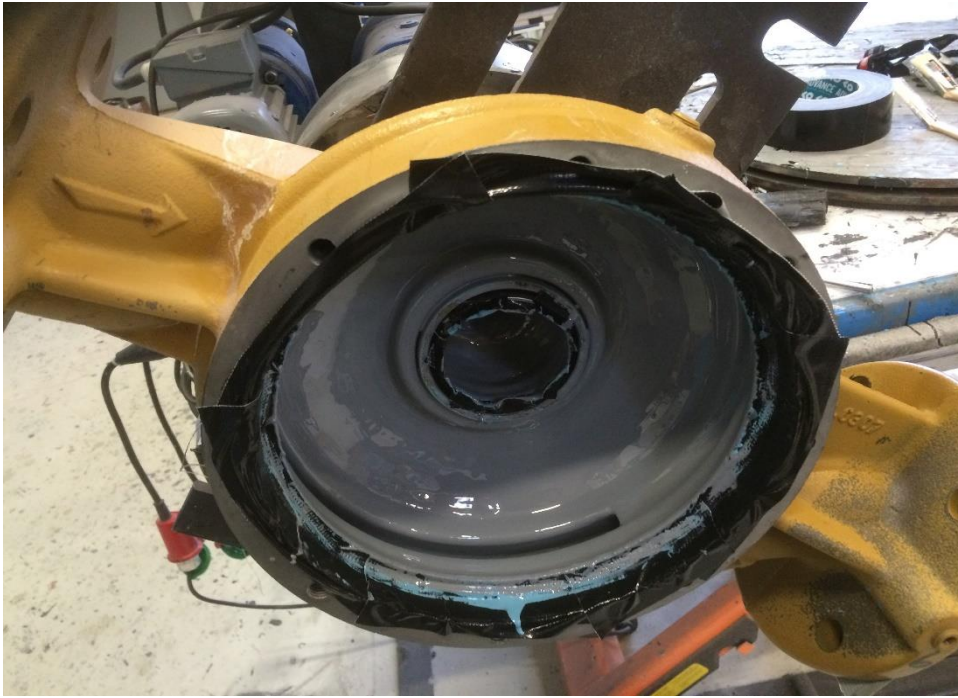
2 coat

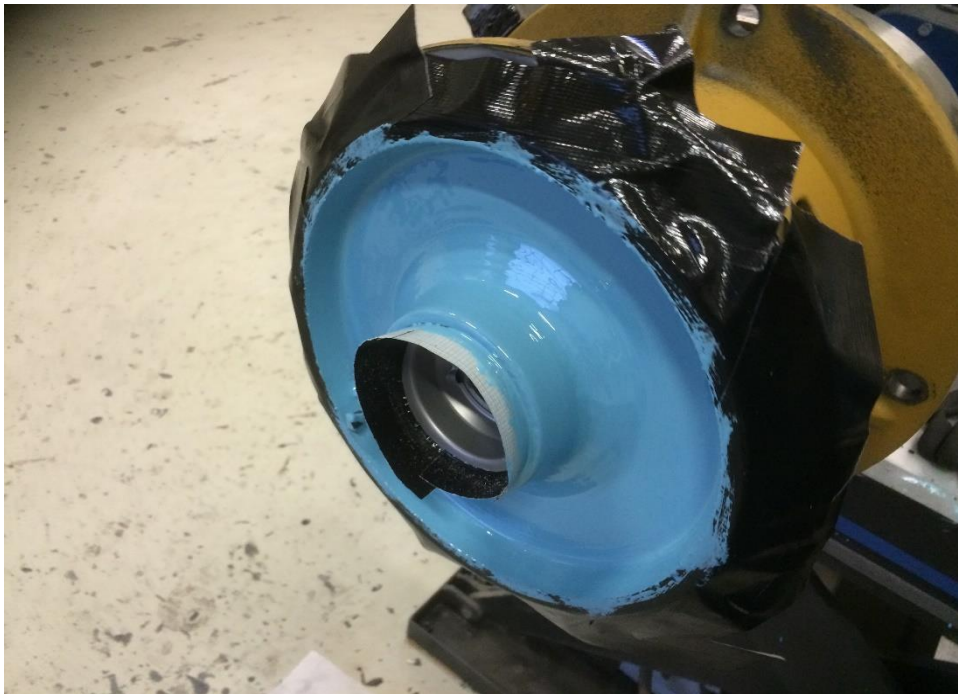
3 coat

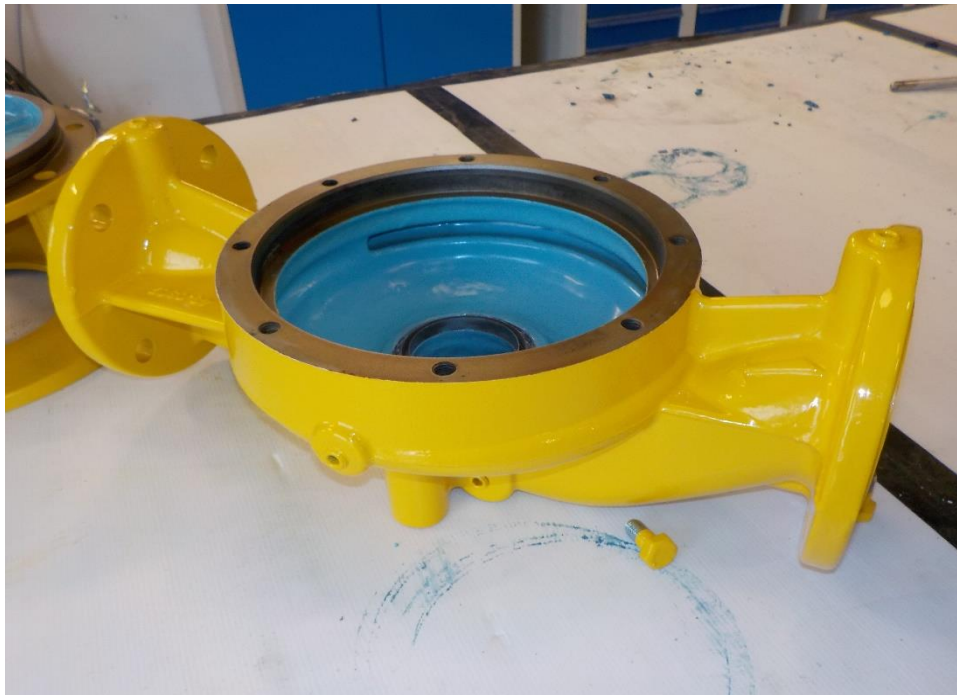
udv coate ral 1032
